FLORENCE COPPER INC.

Subject: Weekly Monitoring Report for Week Ending 07/27/2019
Florence Copper, Production Test Facility
Aquifer Protection Permit No. 106360, LTF 61845

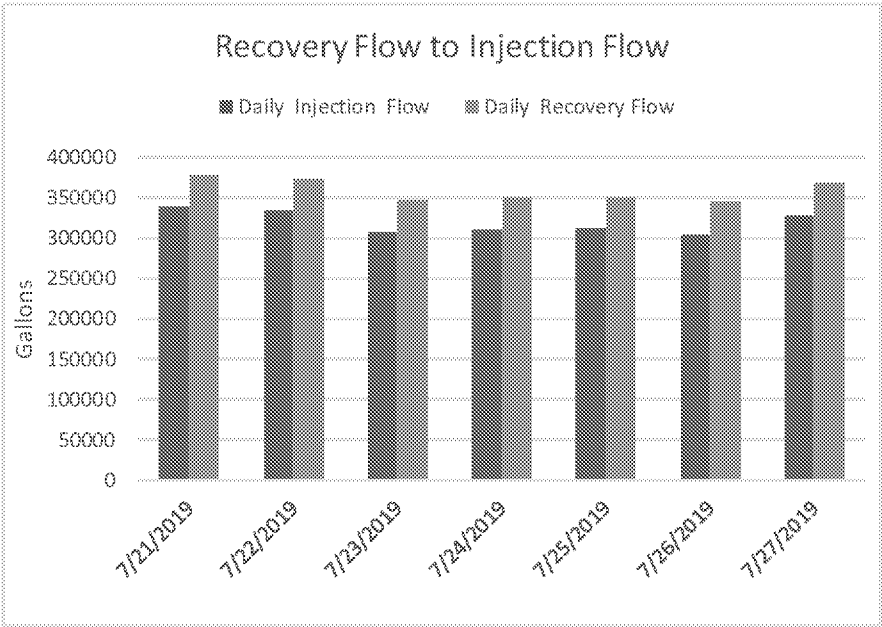
Figure 2. Recovered volume to injected volume

A summary of the injected and recovered volumes for the week 07/21/2019 to 07/27/2019 is included in Table 1. The total injected and recovered volumes for the PTF as a daily total are also presented on Figure 2. On July 25th, recovery well R-09 was converted to injection, and injection well I-01 was converted to recovery. Daily reports were adjusted to reflect this adjustment.

During the reporting period no exceedance of the alert level was measured for recovered volume to injected volume. The alert level is the recovered volume shall exceed the injected volume.

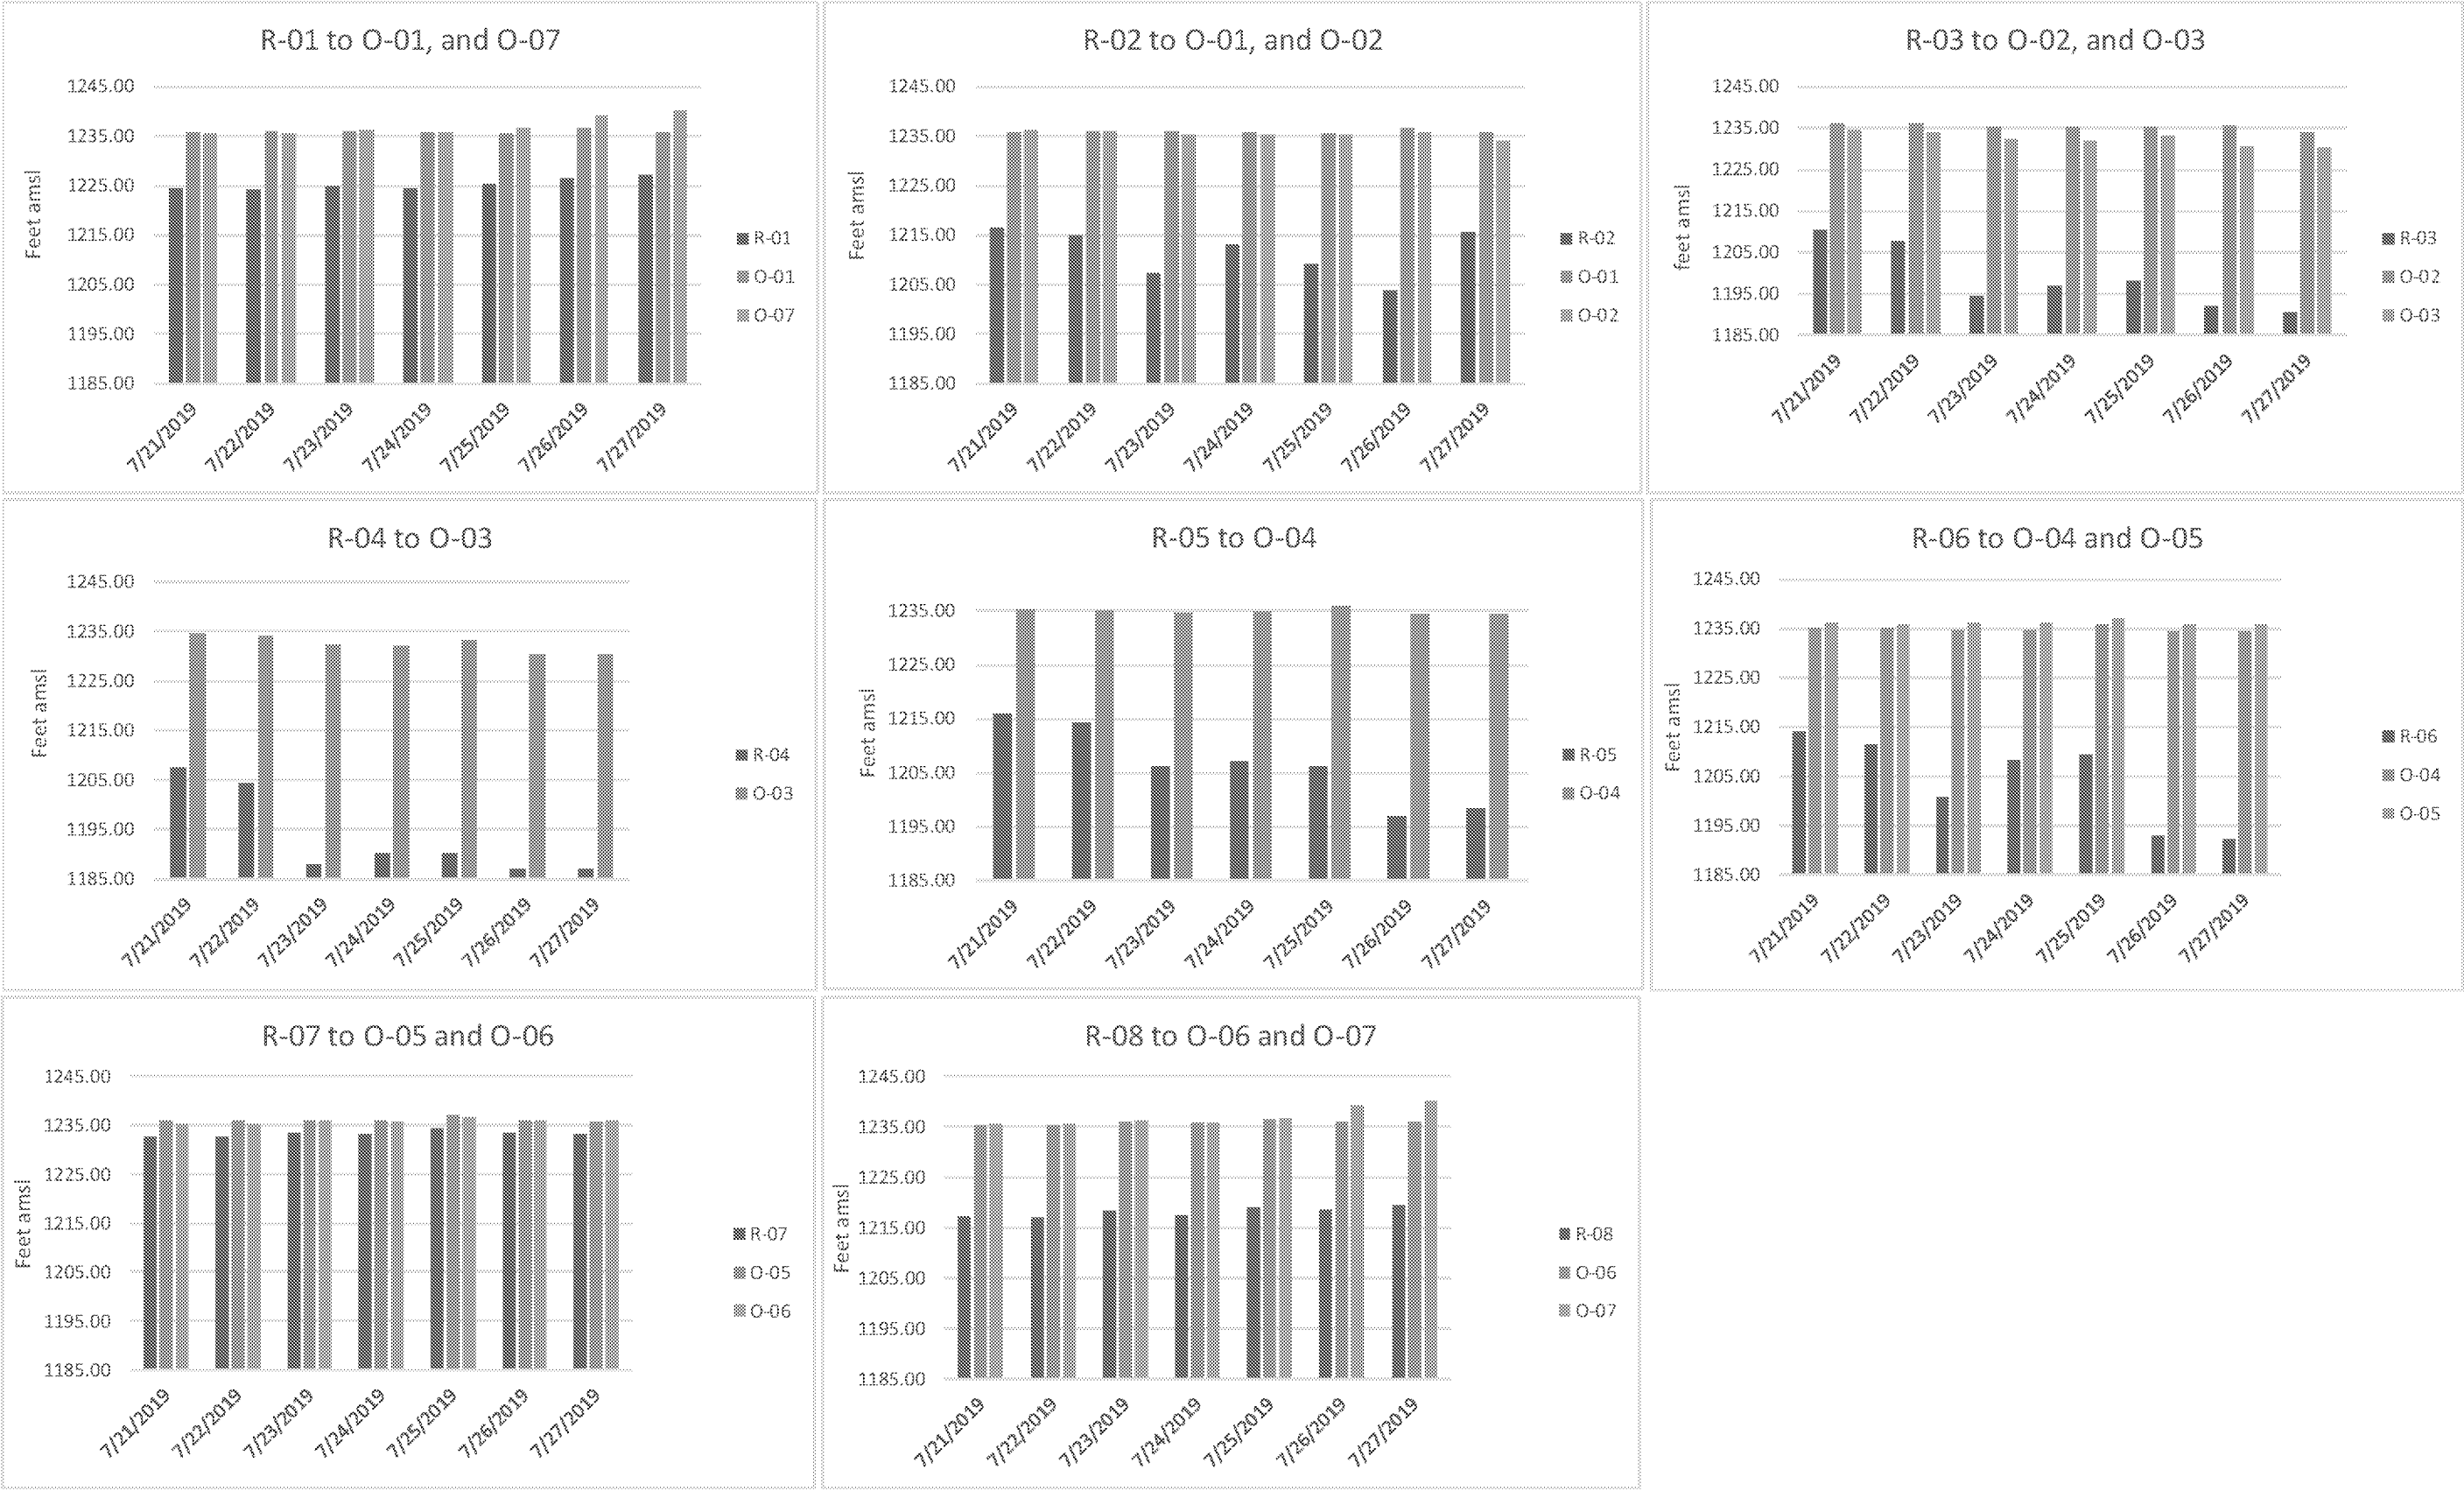
Figure 3. Recovery and observation well pairs

Table 2 includes a summary of water levels in the recovery and observation well pairs. Hydrographs showing the water level elevation for each recovery well and observation well pair are included in Figure 3.

During the reporting period, there was no exceedance of the alert level for the inward hydraulic gradient. The alert level for the inward hydraulic gradient is that the water level elevation in the paired observation well must be a minimum of 1 foot higher than the paired recovery well.
